# Beach Nourishment Effects

Østerstrand Fredericia - Denmark 2017

| Report | Beach nourishment effects - Østerstrand, Frederica, Denmark |

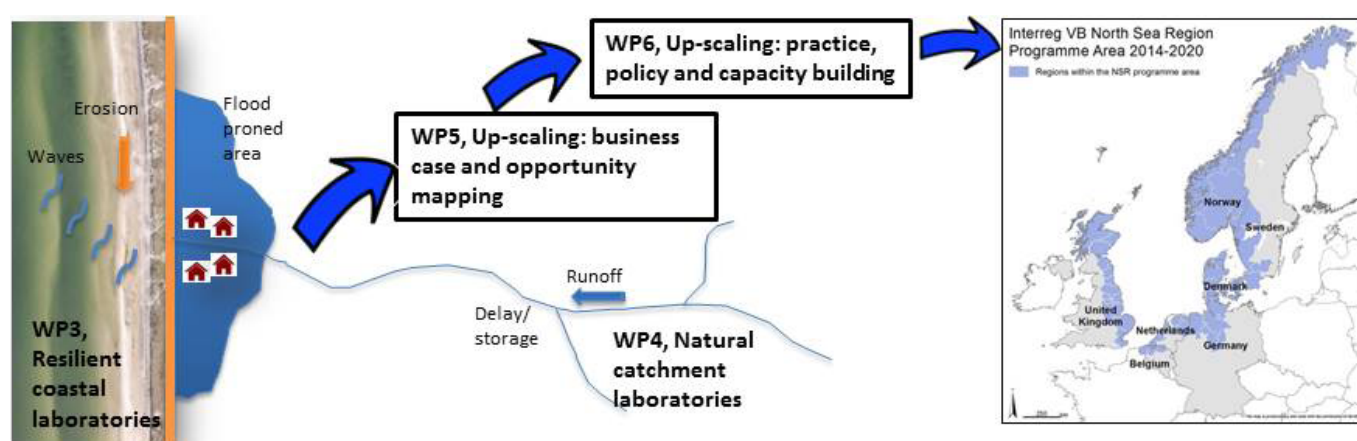
Figure 1.1: The 6 work packages in the Building with Nature project. WP1 - Project Management, and WP2 - Communication is not included as these WP are in-office activities.

The BwN-project is a combination of six different work packages, (Figure 1.1) and this report on Østerstrand in Fredericia (Denmark) belongs under Work Package 3 (WP3): Resilient Coastal Laboratories. However, the coastal stretch in this report is not a laboratory site.

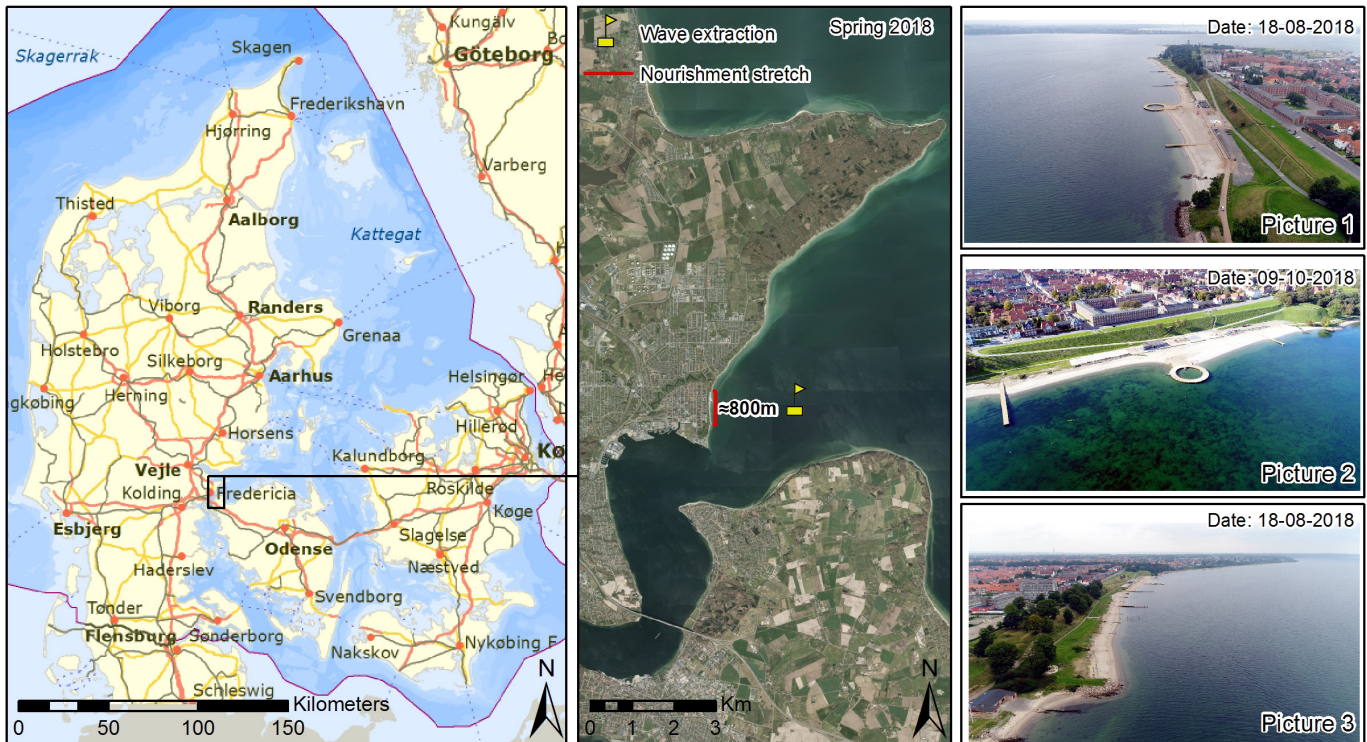
Figure 1.2: The town of Fredericia is located in the SE-part of Jutland. The nourishment stretch is found in the orthophoto, and drone imagery in picture 1, 2 and 3 show the nourishment from three different angles. Picture 1, 2 and 3 are taken more than a year after completion of nourishment. View from the drone images are as follows: Picture 1 is from N to S, Picture 2 is from E to W and picture 3 is from S to N.

The town of Fredericia is located in the SE-part of Jutland and is neighbor to the strait "Lillebælt". As seen in Figure 1.2, the nourishment stretch lies adjacent to the main town center of Fredericia. The combination of location, presence of lifeguards in summer, sandy beach pockets and continuous water quality checks, makes the beach very popular among locals and tourists.

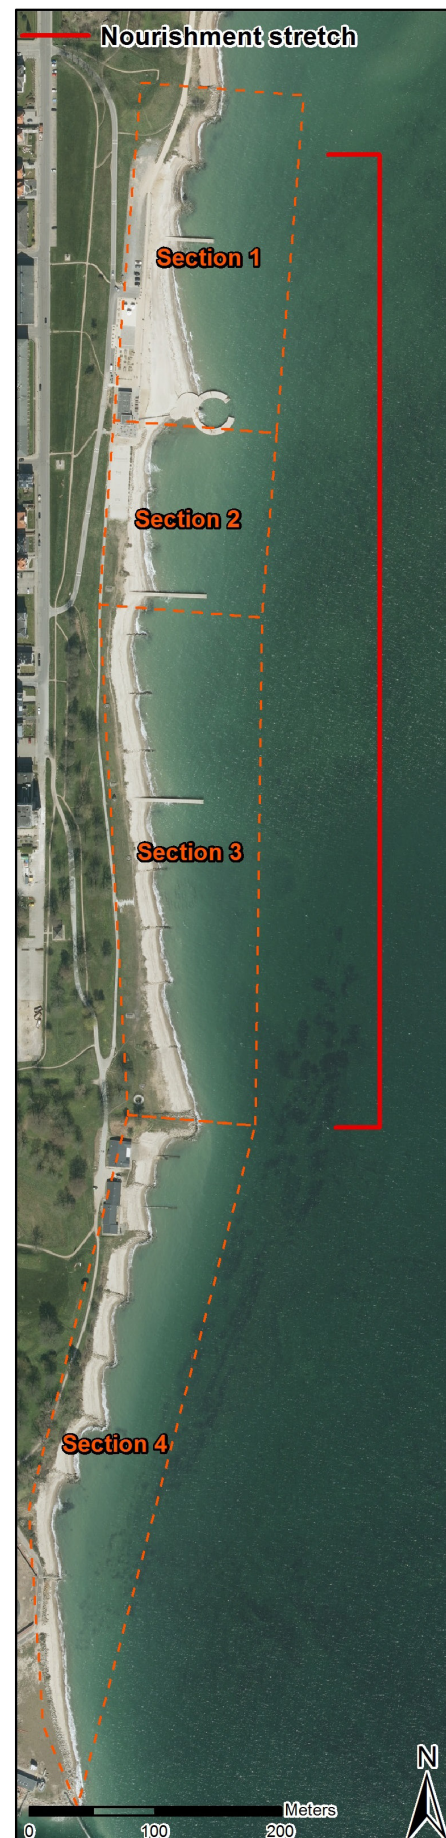
Figure 1.3: Sectional division of the study stretch. Orthophoto from 2017 after Nourishment.

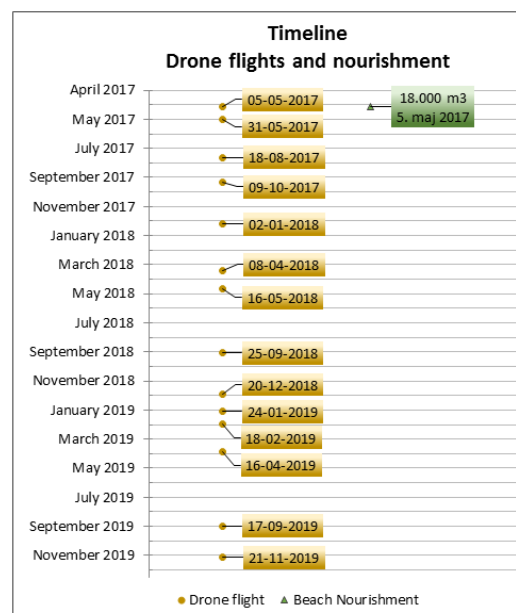
Figure 2.1: Timeline showing the date for the drone flights and the establishment of the nourishment

Drone filming has been done in 4K resolution on 14 occasion with a DJI Phantom 4 Pro. First time was 5th of May 2017, which was just after some of the inland sand had been placed and before the nourishment by ship began. The remaining drone flights were done to follow the development of the nourishment. It has been sought to film the stretch in a comparable way each time so that drone film and imagery can be used to describe the changes over time. Dates are provided on the timeline in Figure 2.1.

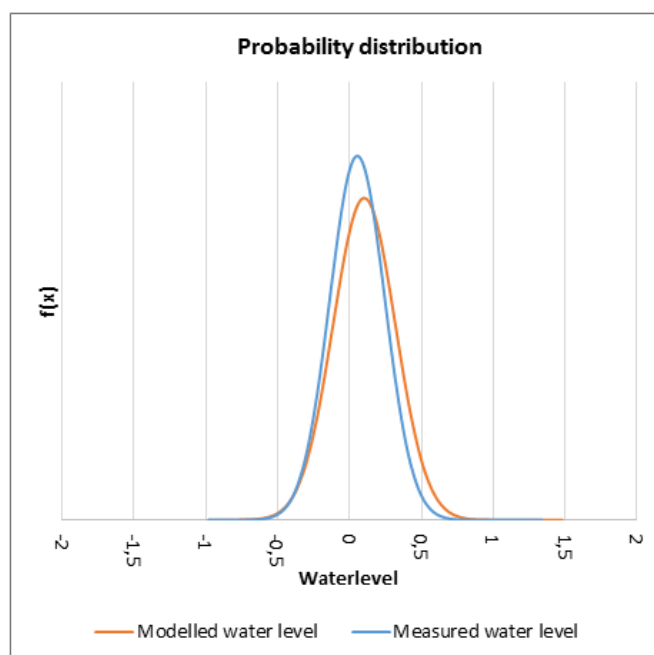
Fig. 2.2: Probability density distribution for modelled and measured water levels.

The probability distribution for modelled and measured water levels are presented in Figure 2.2. This shows that both datasets are close to normal distribution but with the upper tail slightly longer than the lower. The modelled water levels are slightly higher than the measured water levels and has a slightly wider range. The modelled mean is 0.05 m higher than the measured water level.

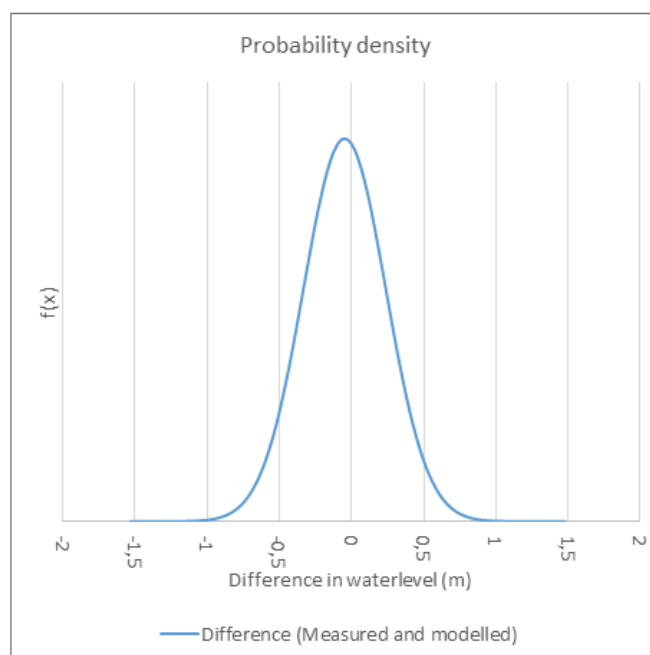
Fig. 2.3: Probability density distribution for modelled and measured water levels.

As the time steps are comparable, the difference between modelled and measured data can be determined for every time step. The sample statistics for the calculated difference between modelled and measured data is presented in Table 2.4. The differences are close to evenly distributed around the mean as also seen in the probability density distribution of the difference in Figure 2.3. The spread of the dif-

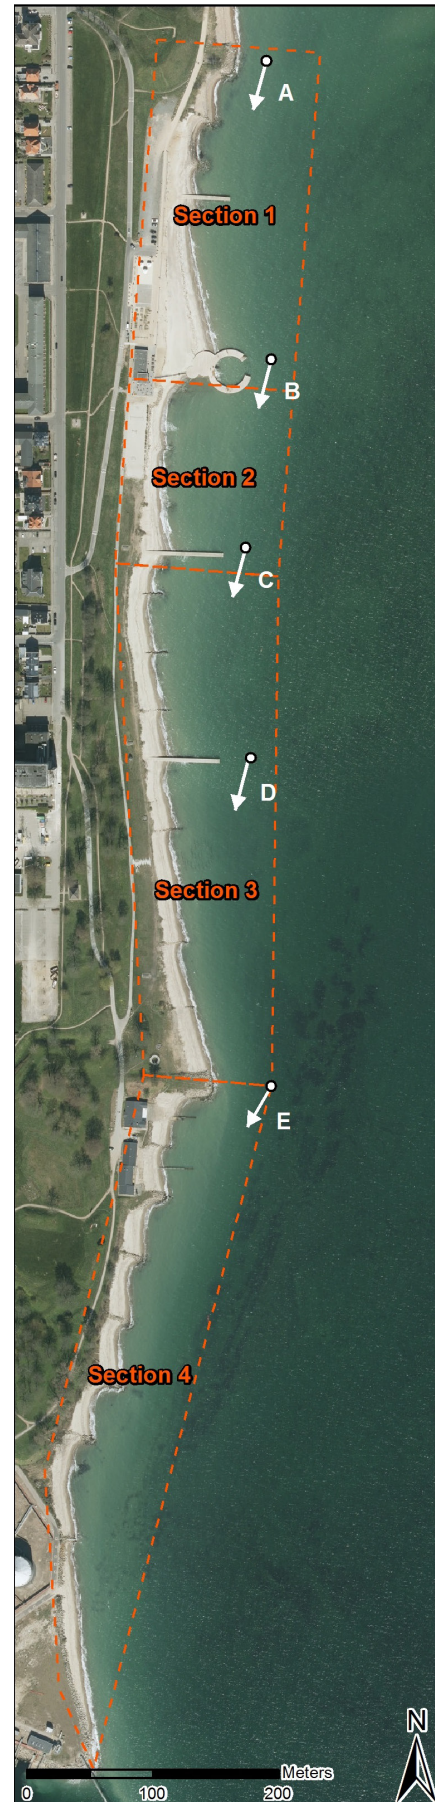
Figure 3.1: White arrows indicate from where and in which direction drone imagery is recorded.

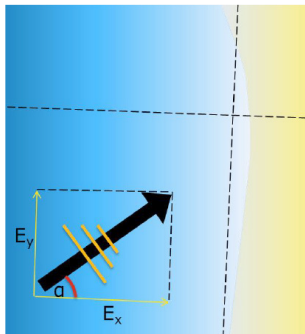
Figure 3.2: Energy decomposition of oblique waves in cross-shore and alongshore directions (Kystdirektoratet, et al., 2018)

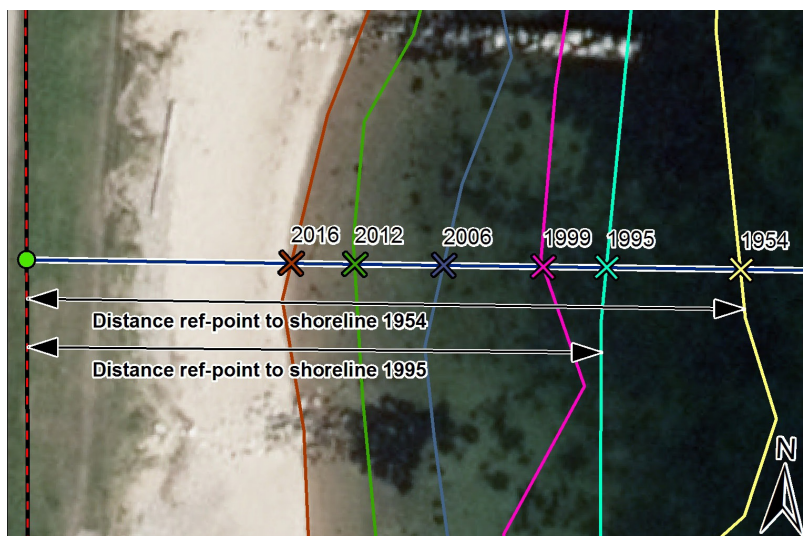
Figure 3.4: The intersections marked with crosses are created as described in the text. Here the shoreline retreat would be found as:  
Retreat from 1954 to 1995 = Distance 1954 - Distance 1995.

The shoreline retreat is estimated at 11 transects along the stretch. These are placed perpendicular to an inland station line with reference points at the end of the transect lines (green dots in Figure 3.3). Intersections between transect and shorelines are found using ArcMaps "Intersect" tool. The distance from intersect point to transect reference point are found using the "generate near table" tool. The referenced distances can then be used to estimate the shoreline retreat as shown in Figure 3.4.

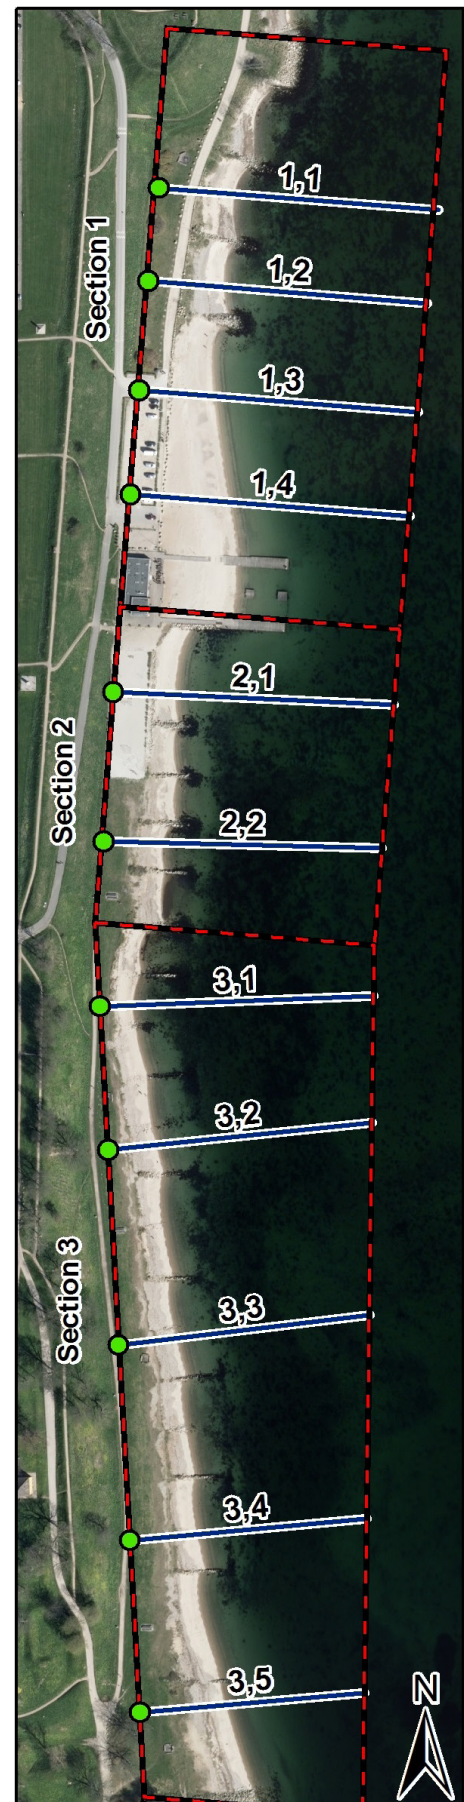
Figure 3.3: Profile lines drawn for estimation of shoreline retreat.

The position of the waterline has been determined from the defined lines in Figure 3.3. The highest rates of retreat in the shoreline is found to be at line 3.1 and noticing the changes in vegetation line at line 3.1 from orthophotos in Figure 4.1, this retreat is coupled with the most pronounced acute erosion for the stretch. The retreat rate decreases slightly from 3.1 to 3.5 and 3.5 even shows seaward migration. The seaward migration at line 3.5 is likely a response to the prolonging of the terminal groyne, which has detained slightly more sediment. Nevertheless, there has still been a general intensification in retreat between 1995 and 2016, compared to the period between 1954 and 1995.

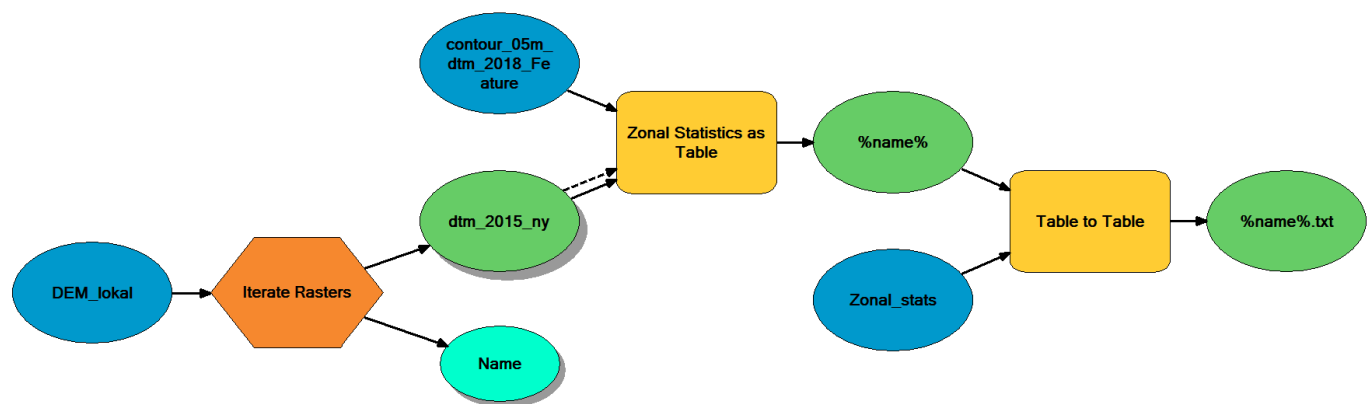
Figure 3.5: The beach volume in each section has been determined using the Model builder shown in this figure. The method is relatively simple, but it is, however, important to set input raster as snap raster to avoid unwanted resampling and set zone to the section number in the input for zonal layer.

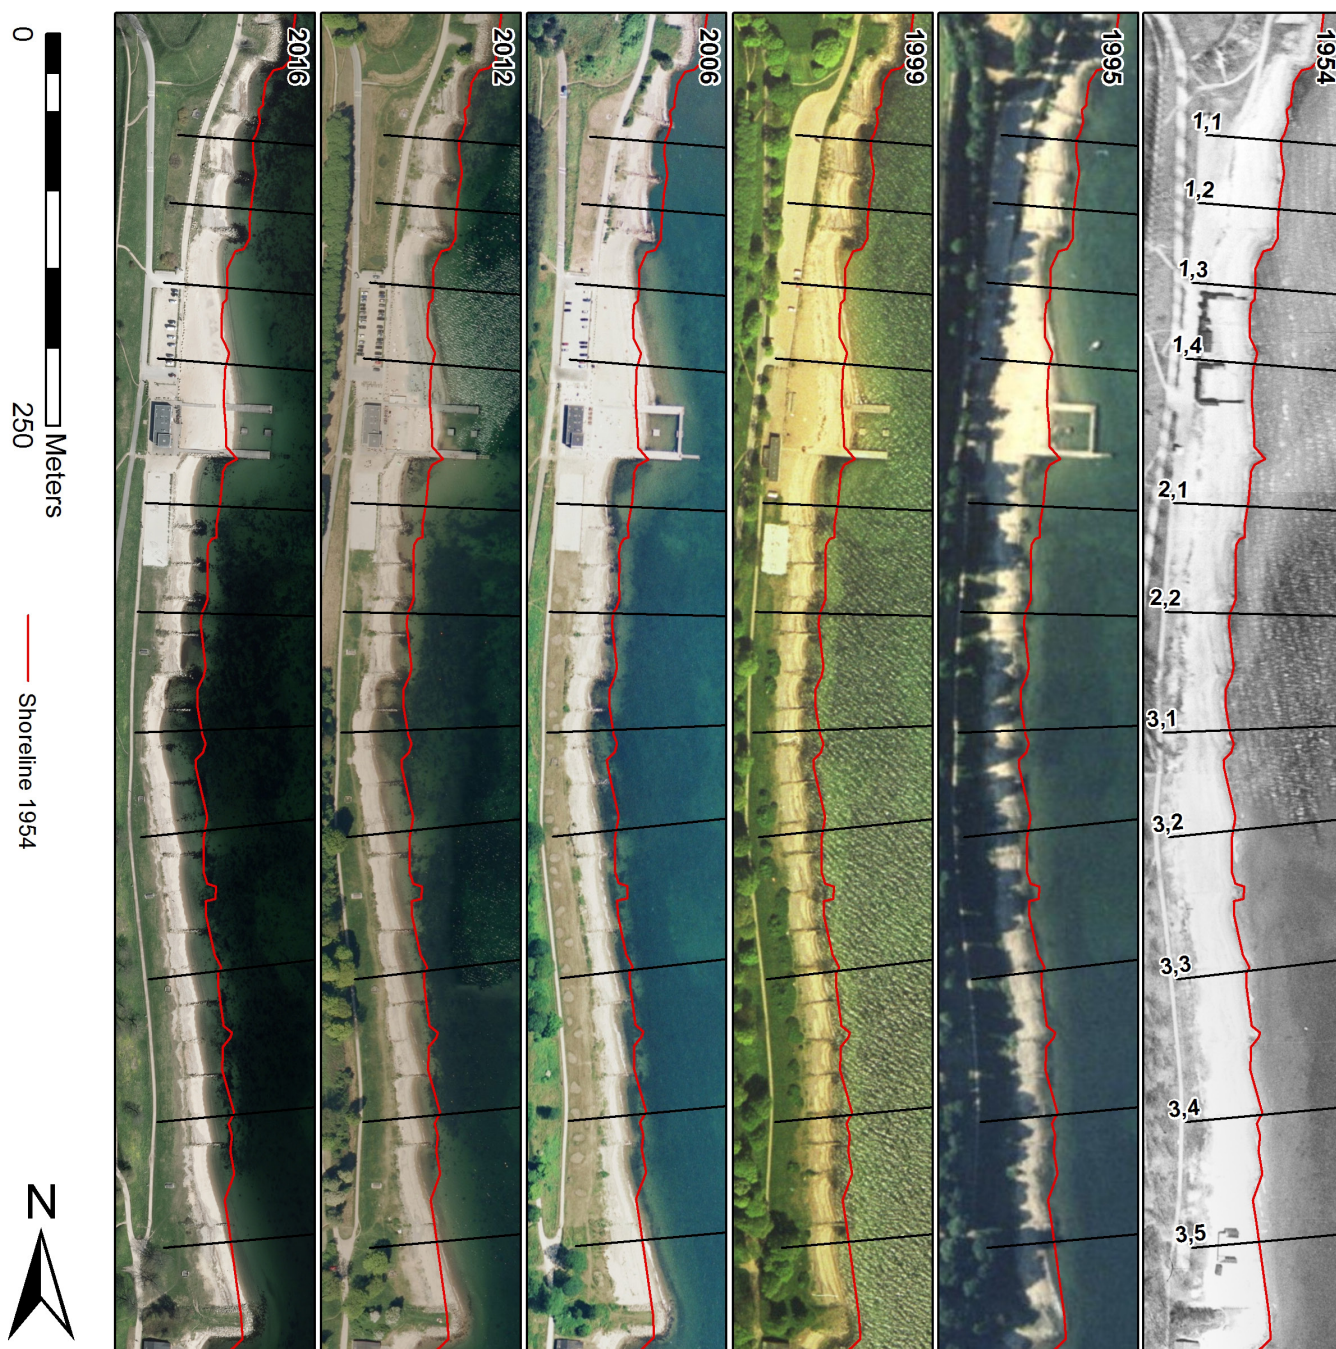
Figure 41: Time stack of Orthophotos at Østerstrand, Fredericia. The Shoreline polyline in red are drawn by hand as the approximate boundary between sand and water on the 1954 imagery.

The beach width has decreased on the nourishment stretch between 1954 and 2017. There is only a slight increase in width on the N-side of the two old swimming piers, which is a result of the upstream side accumulation. The construction of these swimming piers increased the beach reduction on the leeside and the construction an the groyne fields was intensified in the 1980's. Between 1999 and 2004 the Southern terminal groyne was prolonged using stones from some of the older inactive groynes (also seen in Figure 4.1), and there was a reduction in the amount of revetments.

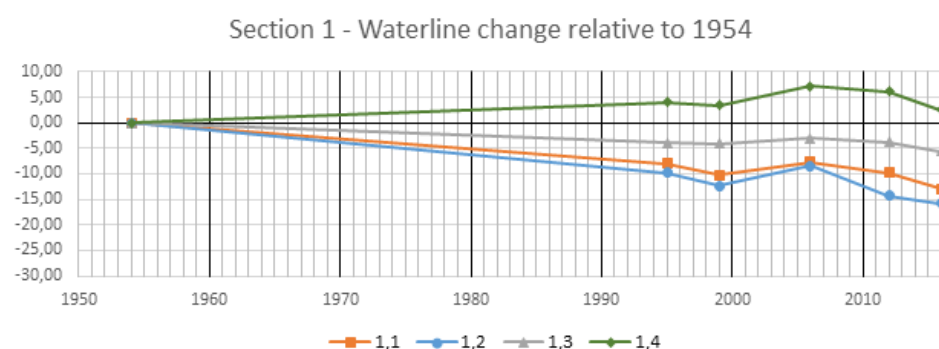
Figure 4.2: Showing the measured shoreline position for the included years, relative to the 1954 position.

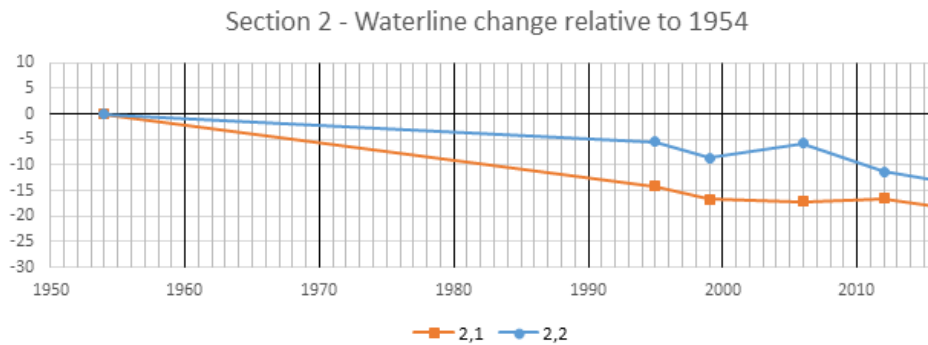
Figure 4.3: Showing the measured shoreline position for the included years, relative to the 1954 position.

The beach width reduction at line 2.2 shows increase between 1995 and 2016. On the contrary, line 2.1 showed decrease in shoreline retreat between 1995 and 2016. The four groynes in section 2 seem to control the stretch and the sediment pockets at the beach.

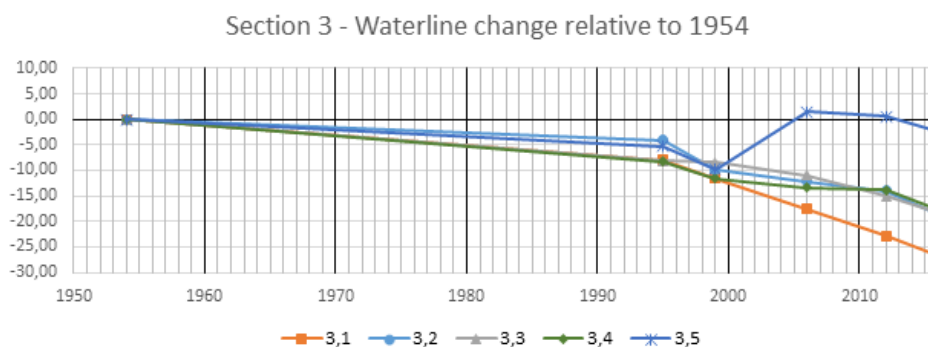
Figure 4.4: Showing the measured shoreline position for the included years, relative to the 1954 position.

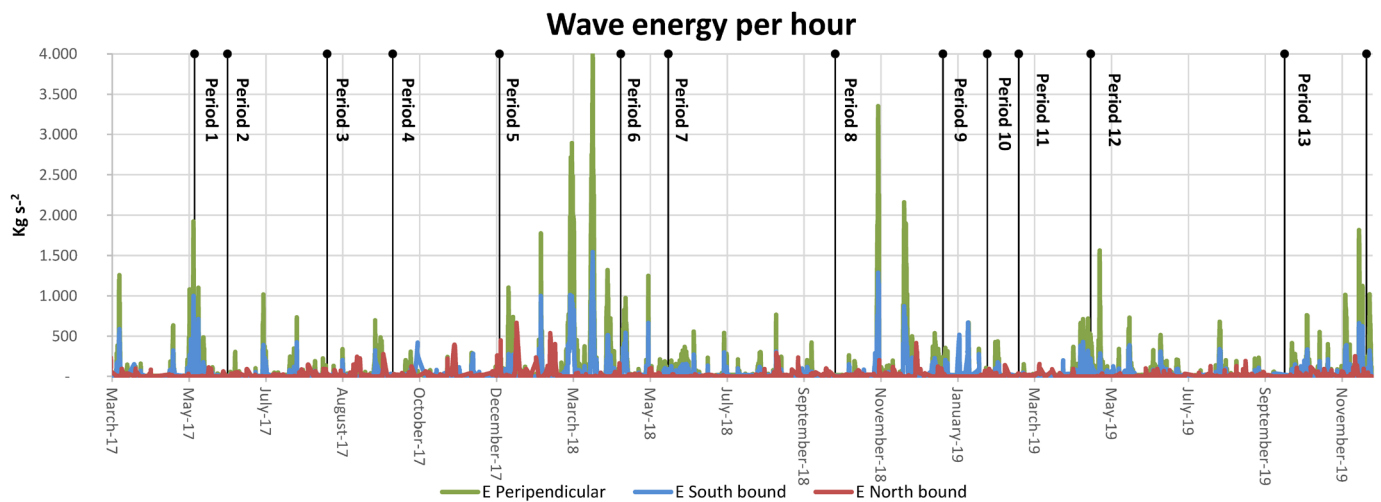
Figure 5.1: The wave energy alongshore (north/south) and perpendicularly is calculated every hour from the method described in Chapter 3. Division into periods is represented as black vertical lines with the respective date attached.

The wave energy is calculated as described in chapter 3. Results of the hourly-calculated energy components are presented in Figure 5.1 and Table 5.1. Significant wave height has been presented in graphs whilst the modelled water level is presented for each period under chapter 5.2.

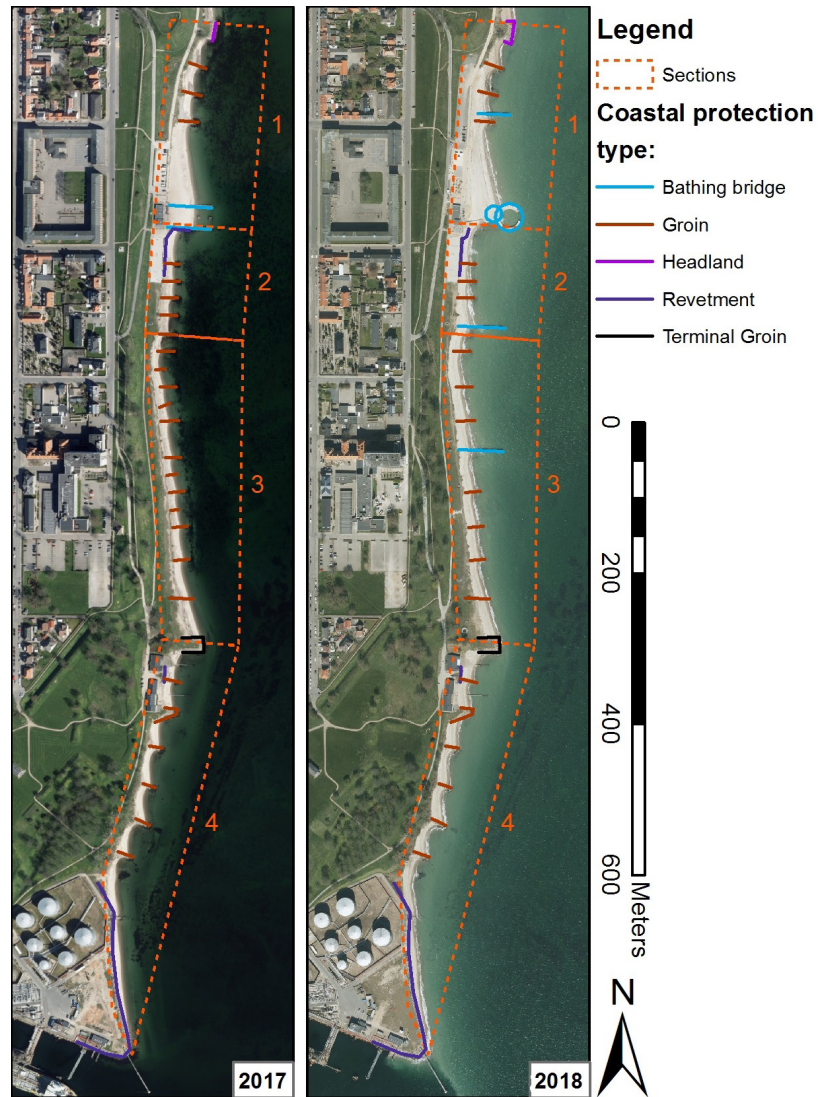
Figure 5.2: Passive hard coastal protection measure before and after the beach nourishment.

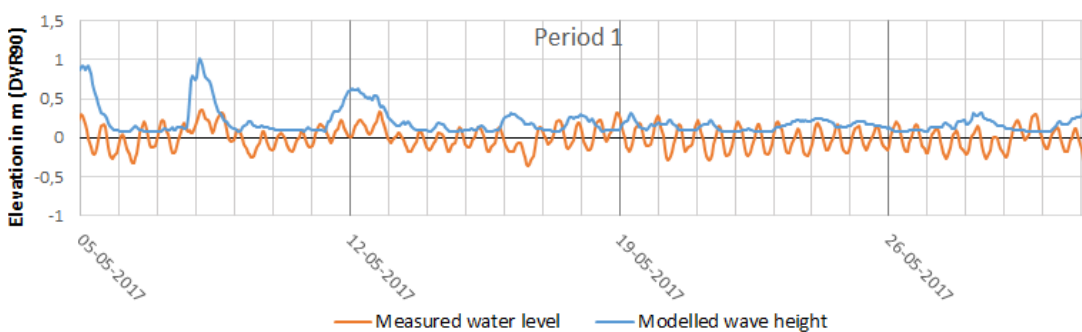
Figure 5.3: Modelled wave height and water level from the DMI dataset for period 1. Note that SWH is short for "significant wave height".

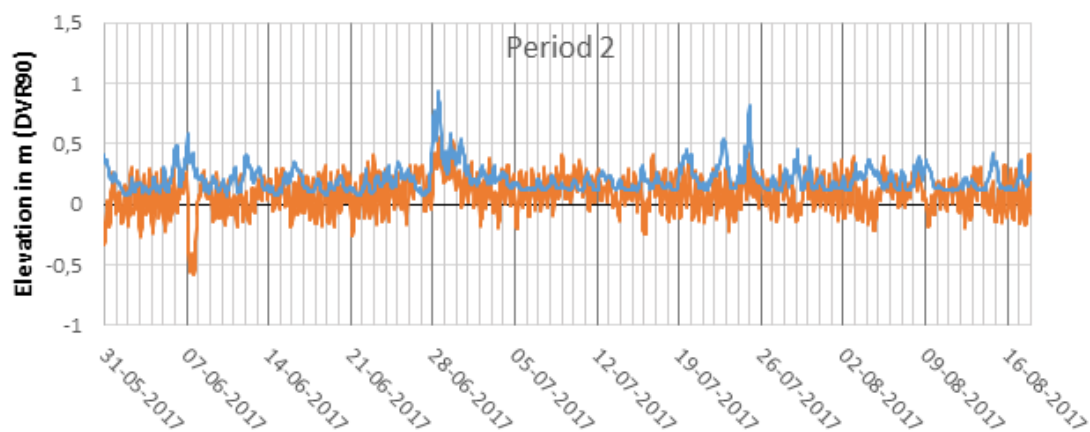
Figure 5.4: Modelled wave height and water level from the DMI dataset for period 2. Note that SWH is short for "significant wave height".

There has been some redistribution of the sediment and in general a reduction in planform. Morphological marks from wave or water level on the beach indicate some redistribution by water. There have been two events with waves above 0.5 m in height, one event between 28th and 29th of June and one on 25th of July. The dominant energy direction in both cases have been cross-shore, as seen in Figure 5.1, and the water level at the time has not been enough to reach the upper sections of the beach. Since the water level only reaches +0.5 m, the upper beach sections have not experienced any significant changes.

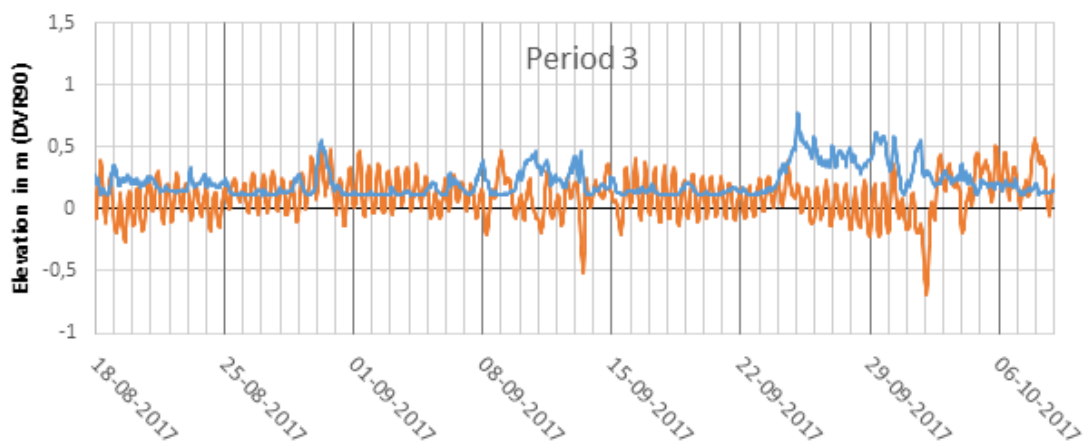
Figure 5.5: Modelled wave height and water level from the DMI dataset for period 3. Note that SWH is short for "significant wave height".

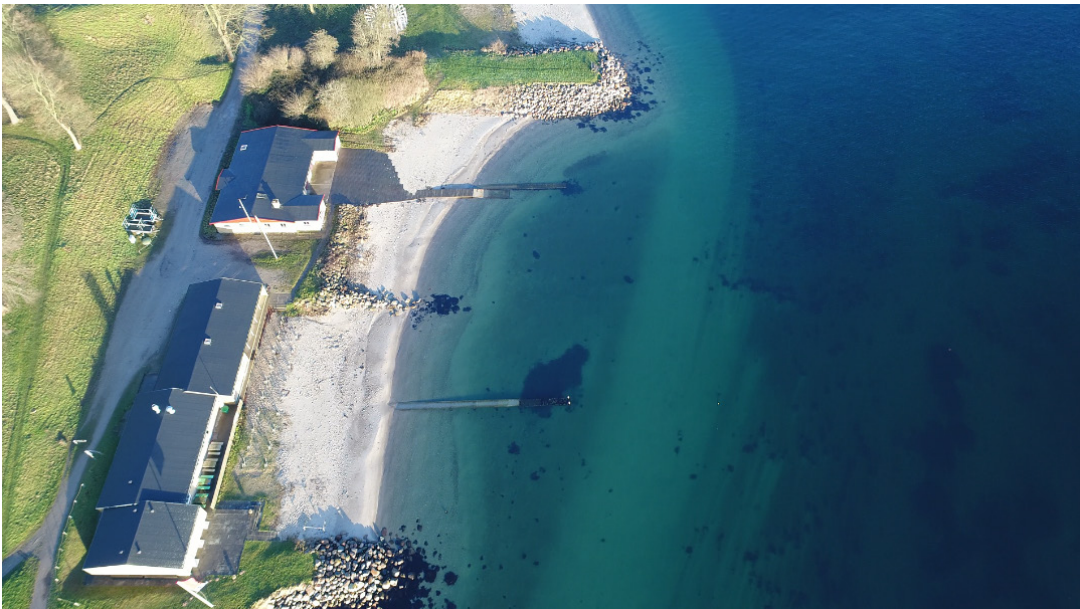
Figure 5.6: Frame extracted from the drone film made on the 02-01-2018. The image shows the rowing and kayaking club in the N-end of section 4. The longshore transport is evident in the sediment fan from the terminal groyne of section 3 towards S in section 4.

**Section 4:** Accumulation is taking place in the berm in front of the rowing clubs. Furthermore, the longshore transport around the terminal groyne has become very clear. Figure 5.6 illustrate how a sheet or longshore bar of sandy sediment migrates from north to south around the terminal groyne in section 3. Furthermore, the bottom section of the image indicates that leeside accumulations behind either underwater vegetation or stones are taking place.

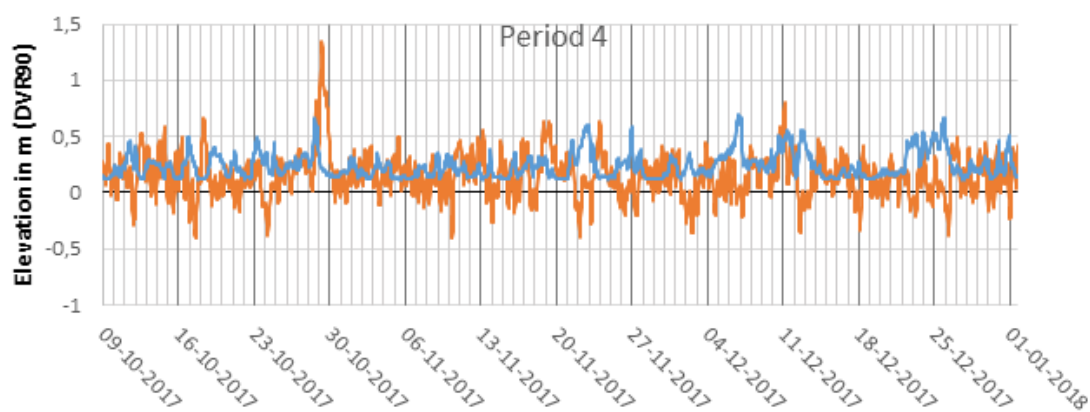
Figure 5.7: Modelled wave height and water level from the DMI dataset for period 4. Note that SWH is short for "significant wave height".

There has been a general increase in berm height despite a reduction in beach width. Additionally, the shoreface shows indications of at least one bar building up. The maximum water level in period 4 has reached 1.5 m at its peak on 29th of October, but as there has generally been little wave energy impact during the period, there has not been any visible decrease in the nourishment width. Instead, it has been observed that the berm has increased in height. As period 4 generally has been dominated by higher water levels and multiple events with low energy waves, this can have led to sediment being transported back to the shoreline after cross-shore dissipation. Period 4 is the period with lowest overall wave energy impact.

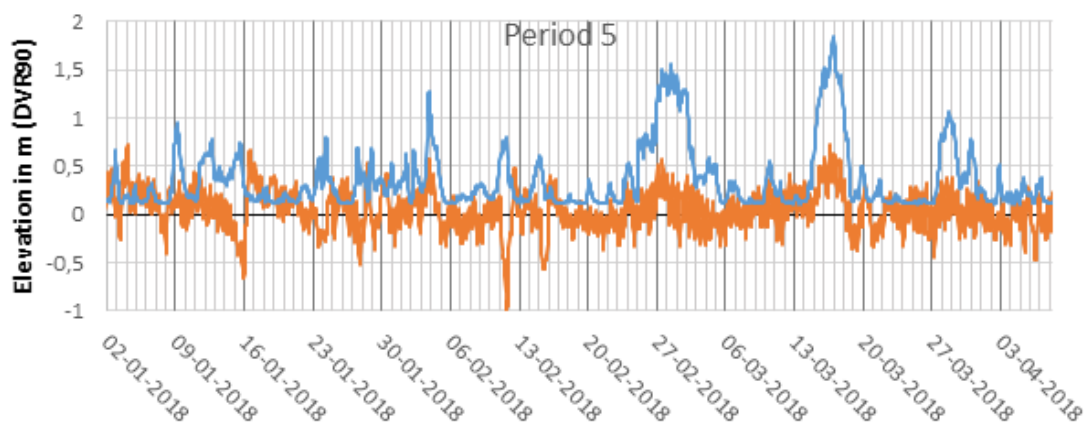
Figure 5.8: Modelled wave height and water level from the DMI dataset for period 5. Note that SWH is short for "significant wave height".

As period 5 can be considered a storm period, it is not unexpected that there has been a significant change in the beach nourishment planform. Multiple high-energy events have impacted the stretch during period 5 but the most significant storms are on 25th of February and on 17th of March. Here wave height reached more than 1m in height for several periods longer than 24 hours and with peaks above 1.5 m. This in combination with water levels above +0.5 m has been the reason for the change and redistribution of sediment. The maximum extent of the swash is seen on the beach, and waves have clearly reached the top of the beach and in some areas even the toe of the grass flats causing acute erosion. As the system in general was out of equilibrium before the nourishment, most of the redistributed sediment is likely to have been transported cross-shore, which corresponds well with the primary cross-shore energy component during the period. The sporadic increases in beach width seen for period 5 needs to be considered, as the water level was more than 40 cm lower than on 8th of April 2018, compared to the previous photos from 2nd of January 2018. Generally, the sediment composition of the beach have coarsened and the beach has flattened.

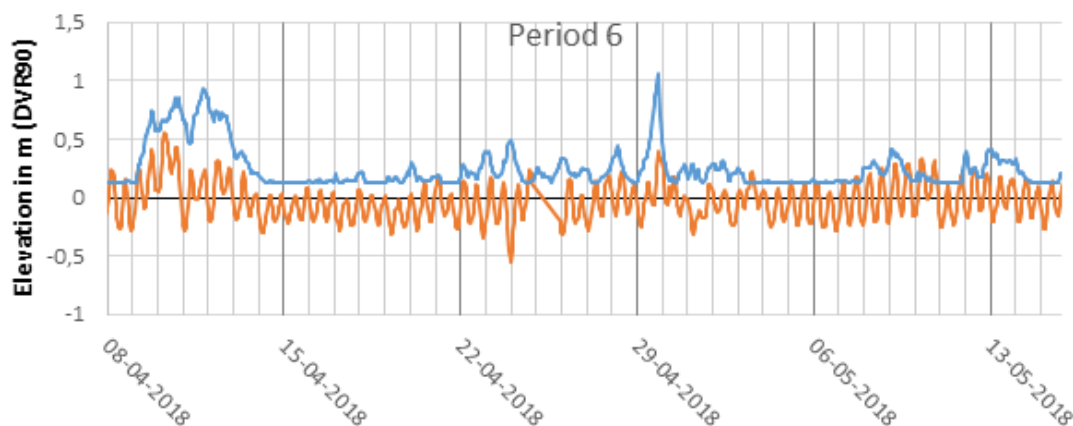
Figure 5.9: Modelled wave height and water level from the DMI dataset for period 6. Note that SWH is short for "significant wave height".

Period 6 shows two wave energy peaks, which corresponds, with peaking wave height. It is noted that there is no indications of volume reduction in the period despite the peaks in energy. In period 6 the groynes have controlled the planform of the beach on the stretch, which corresponds well with the energy calculations. They show a general predominant cross-shore energy component. This period also shows a significantly higher S-bound energy component compared to the N-bound energy. In fact more than 10 times higher.

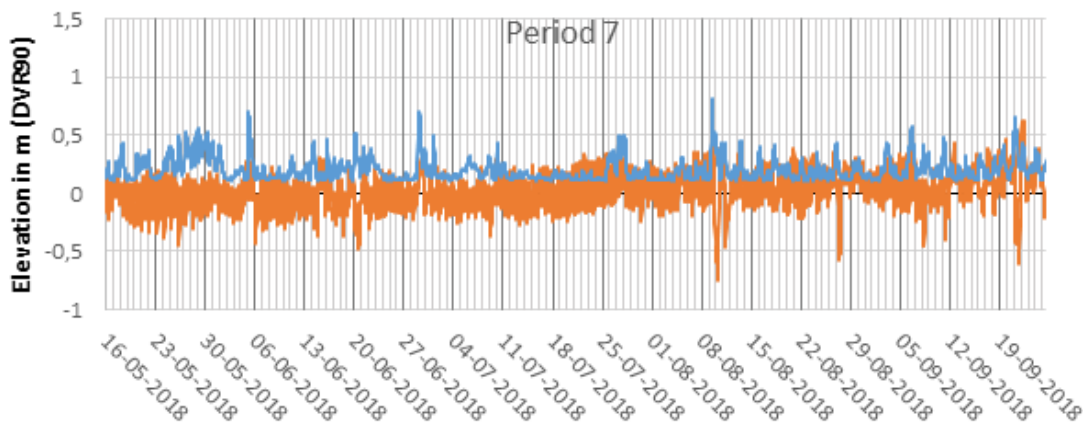
Figure 510: Modelled wave height and water level from the DMI dataset for period 7. Note that SWH is short for "significant wave height".

The water level is found to be 0.2 m lower than in the prior imagery. The beach width might have appeared larger than they actually would be at the same water level. An overall decrease in beach width is therefore assumed for period 7. This period has the second smallest energy component and is dominated by a cross-shore energy component. The impacts and responses during period 7 have high similarity to those in period 4 and the resulting increase in berm height is seen in both periods. The N-bound energy component in period 7 is the smallest measured for all periods and most of the redistribution is likely to have been cross-shore.

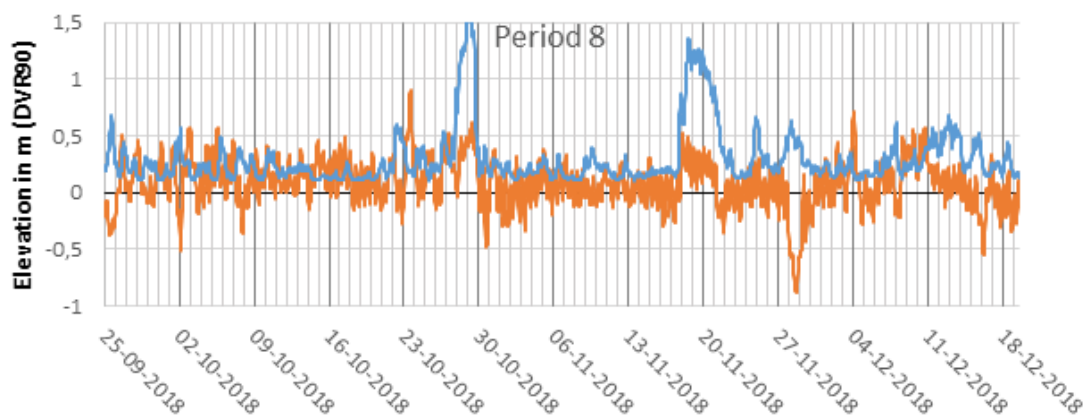
Figure 511: Modelled wave height and water level from the DMI dataset for period 8. Note that SWH is short for "significant wave height".

There has been a general reduction in beach width along the entire study area stretch, even in the downstream sections. Despite a lower energy impact during period 8 compared to period 5, period 8 showed two significant energy events of the same magnitude as seen in period 5. Between 29th and 30th of September 2018 wave heights reached 1.5 m with water levels above +0.5 m and between 18th and 21st of November wave heights was above 1 m during the entire period, not with the same water levels, but was more consistent and endured for a longer period. The reduction in beach width, and presumably volume, can thus again be linked to storm events. Although morphological marks indicate that waves have been at the top of the beach sections, the storm impacts did not result in acute erosion nor retreat of the vegetation line.

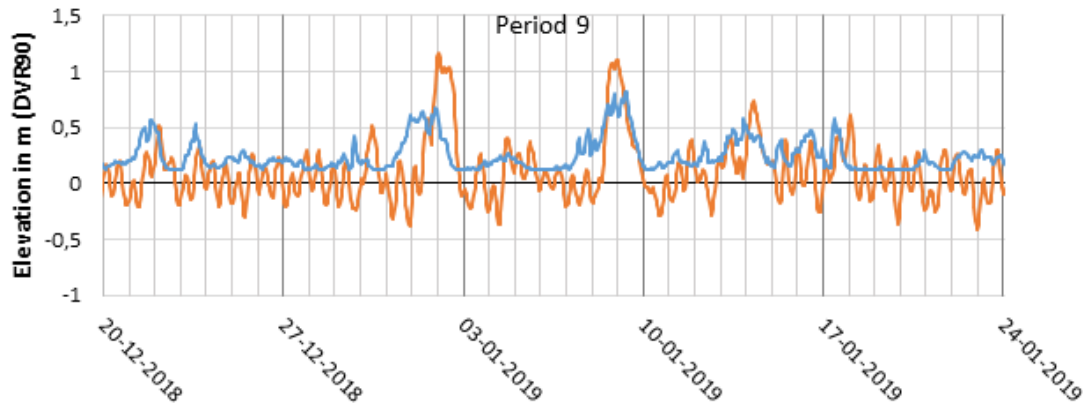
Figure 5.12: Modelled wave height and water level from the DMI dataset for period 9. Note that SWH is short for "significant wave height".

There are clear signs of accumulation on the beach – this is especially seen as the groynes are now partly covered with sediment. The increase in beach width could be a result of lower water levels, but it could also be the results of sediment migrating landward after the latest storm period, which would resemble the changes also seen in period 6. The combination of increasing beach width and partial covering of the groyne parts on the beach could be linked to the 3 periods of high water reaching +0.6 m which correlates with low wave energy impacts as seen in Figure 5.12. This period also shows a dominant cross-shore energy component and the southbound energy component is only double that of the northbound, which is only seen in period 4, while the remaining periods show that southbound energy in general exceeds the northbound energy with at least a factor 4.

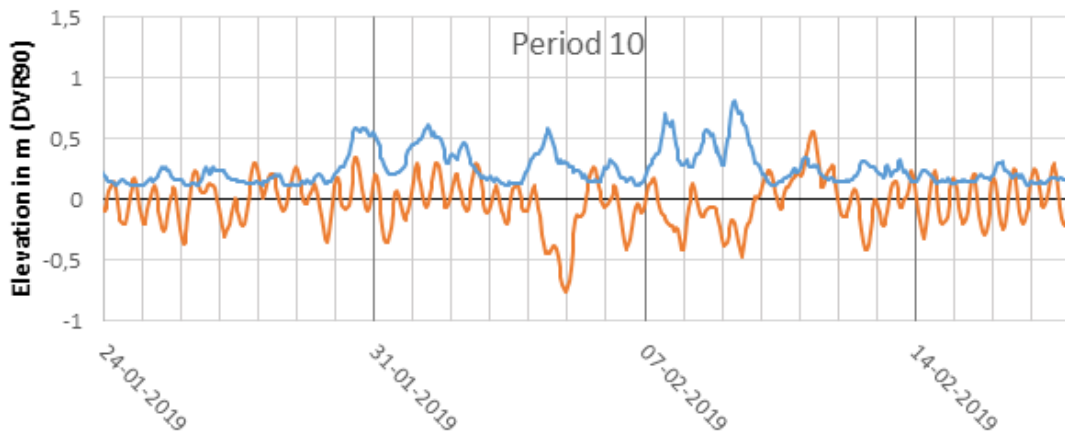
Figure 5.13: Modelled wave height and water level from the DMI dataset for period 10. Note that SWH is short for "significant wave height".

There are only few changes in this period, but the time between the imagery coincides with a time with no significant energy impacts, nor high-water events. The energy is comparable with that of period 9, but the data show no high water events of the same magnitude as in period 9 and the southbound energy component is far lower, making the cross-shore component the far most significant in this period.

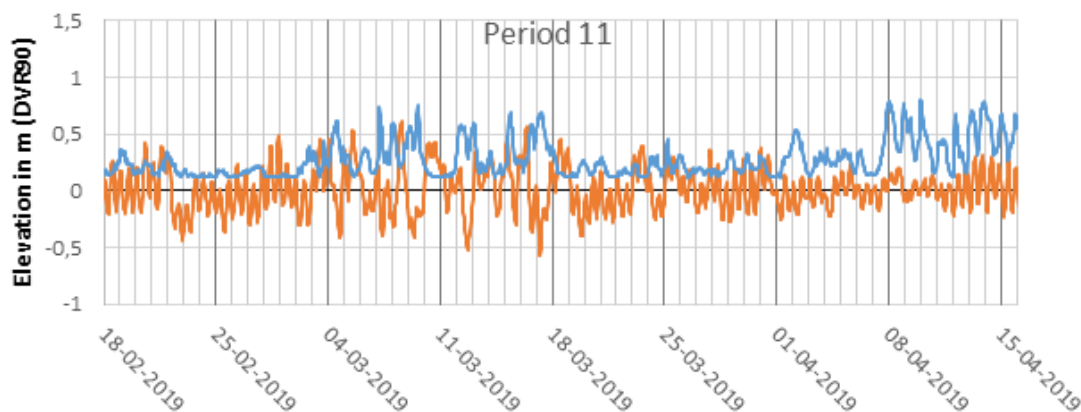
Figure 5.14: Modelled wave height and water level from the DMI dataset for period 11. Note that SWH is short for "significant wave height".

The reduction in beach width in section 3 is linked to the wave energy during the last 9 days of period 11. Multiple occasions with wave height above +0.5 m has occurred while the cross-shore and southbound energy components are dominating. The southbound energy components are also indicated by the groynes, which again have steered the planform of the beach to be exponential between groynes, with accretion on the upstream side and erosion on the downstream side of the individual groynes.

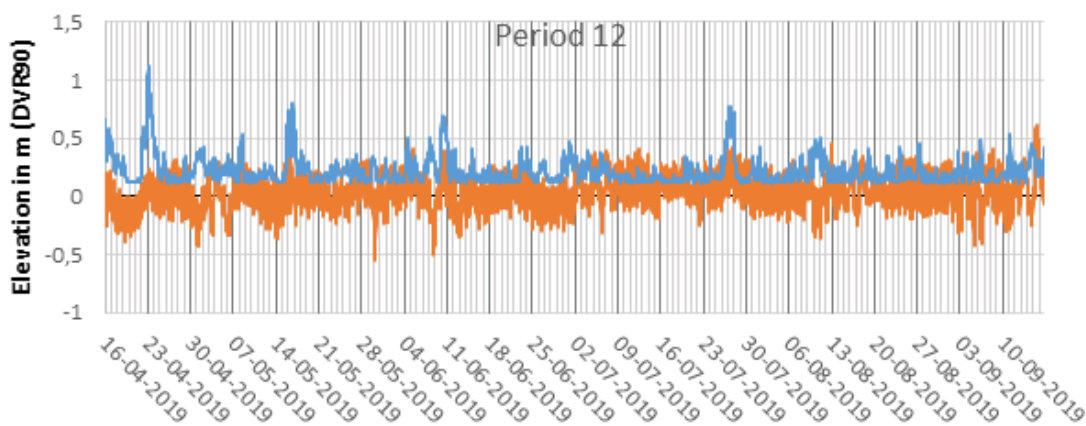
Figure 5.15: Modelled wave height and water level from the DMI dataset for period 12. Note that SWH is short for "significant wave height".

There is a general indication of sediment re-entering to the berm and the swash along the entire nourishment stretch. The sediment is still found to pass by the terminal groyne in a southbound direction, but here it is mainly seen that the sediment is placed along the shore at the tips of the groynes. There is a peak in cross-shore energy on the 23rd of April which is also seen in the wave heights of Figure 5.15, but apart from that event, there are only minor energy peaks, and no events of significant duration with either high-water nor high energy wave impacts. This explains the few changes while the steering of beach planform is not as clear in this period as it was in period 11. This is likely to be the result of dominating cross- and northbound energy during the last month of the period.

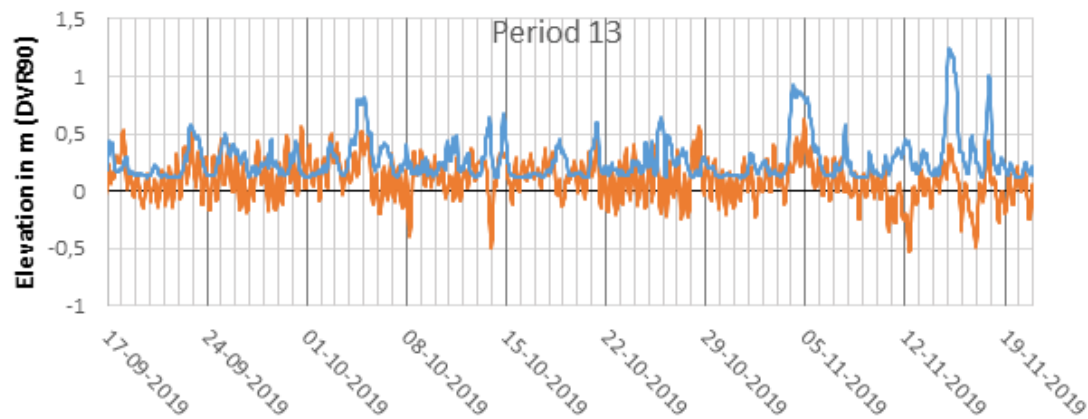
Figure 5.16: Modelled wave height and water level from the DMI dataset for period 13. Note that SWH is short for "significant wave height".

No significant changes are detected regarding beach width. On the other hand, the berm height decreases and there is a flattening of the swash. This corresponds well with three events within the last 21 days of the period when the waves reach more than 1 m in height, but at normal to low water level. In general, the run-up from the waves is likely to have been limited to the mid-section of the beach.

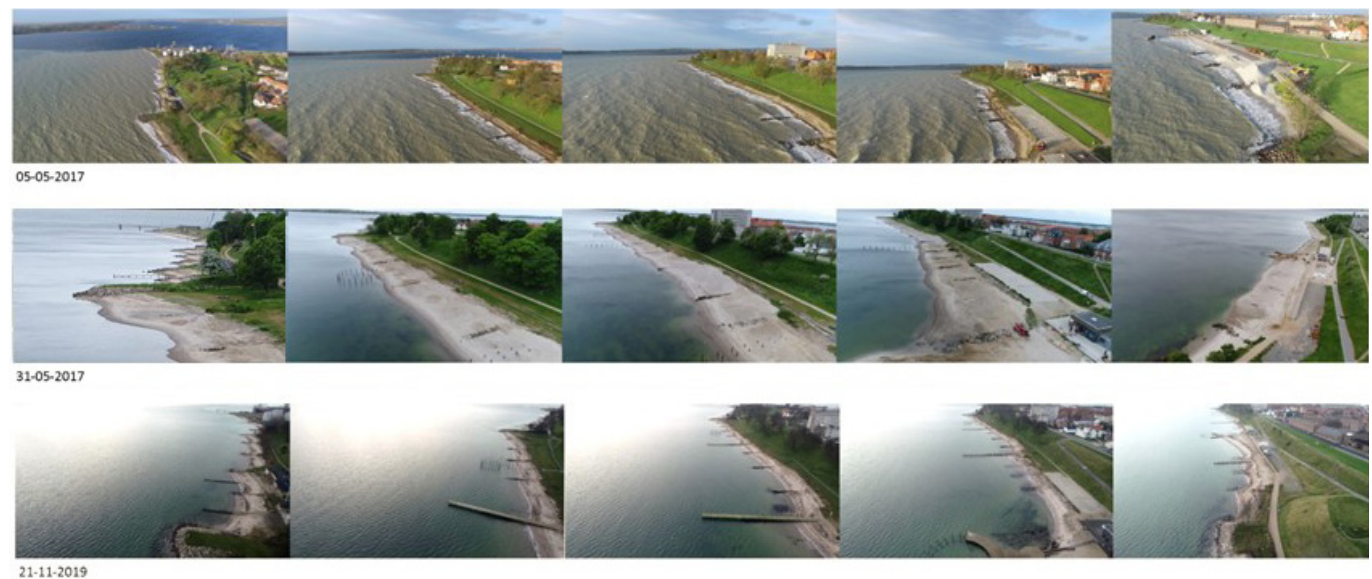
Figure 5.17 Drone images before, just after and 2½ y after beach nourishment

The beach nourishment has resulted in a general advance of the coastline, which has generally widened the beach at the nourished stretch. On average, there is still an advanced coastline after 2½ years.
