# Beach Nourishment Effects

Østerstrand Fredericia - Denmark 2017

| Report | Beach nourishment effects - Østerstrand, Frederica, Denmark |

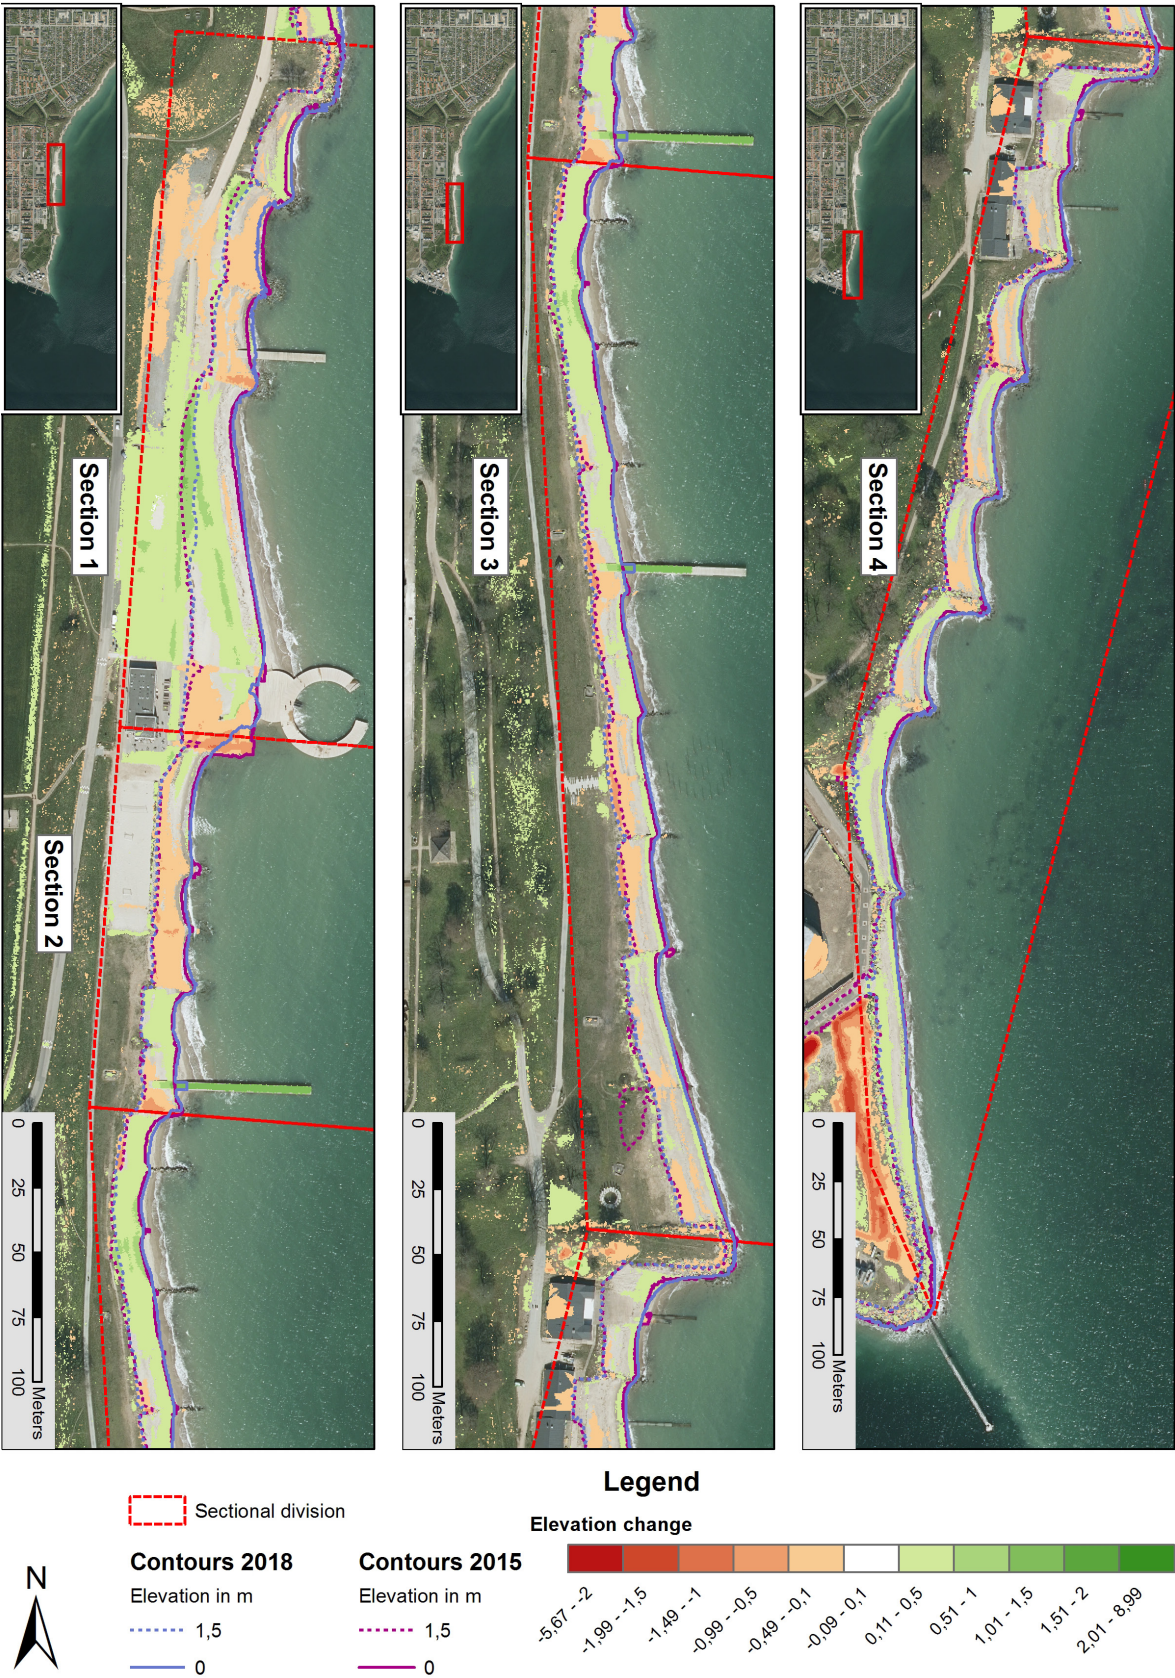
Figure 518: Difference mapping between the two national terrain elevation models. The beach volumes are quantified within the total extent of the 1,5m contours and 0m contours in table 3.5.

**Section 1:** – There is a general increase in beach volume between 2015 and 2018. It is clear that the primary increase in volume is found between the northern jetty and the circle jetty. This is likely to be part of the additional buffer nourishment, which was placed in this stretch, only. The beach has both de- and increased in width along the stretch, but in the northern half the reduction of the groynes meant that the beach could develop more naturally, which could explain the reduction in height. The changes at the south end with the new jetty and changes in construction are responsible for the decrease in beach height here.

The standard error of the national DEM from 2014/2015 and 2018 is accepted to be 5cm. This means that in section 1 to 3 (total area from Table 5.2 ~ 13.5 x 103 m²) there is a possible bias error of up to -700m³. This does not change the above results.

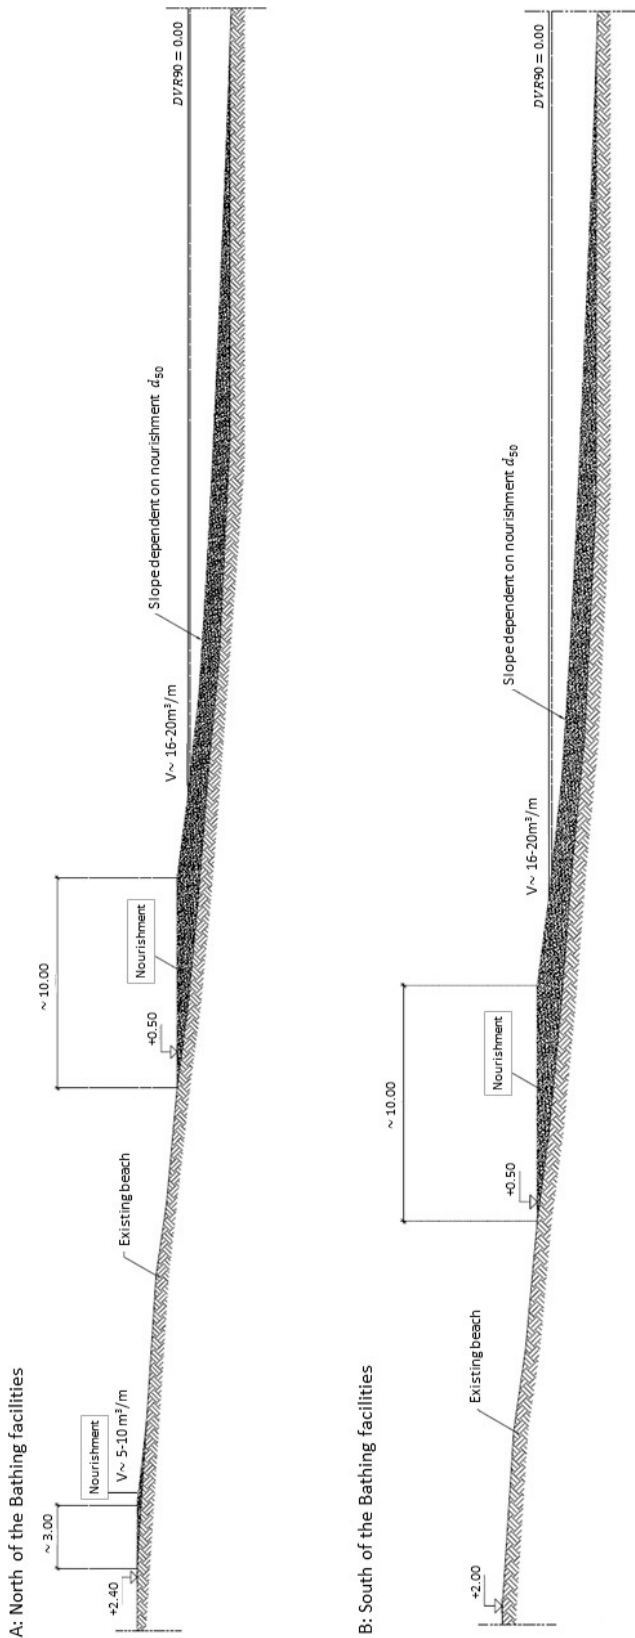
- Cross sections of planned nourishment

Cross-shore profiles from north of the swimming facilities (Cross section B-B) and south of it (A-A) are presented in Appendix B, modified from Danish into English from the original application for the construction.
